# **Enhancing Engine performance**and Emissions

## Test Bus 1 before and after measurement "NPS Engine Improvement treatment"

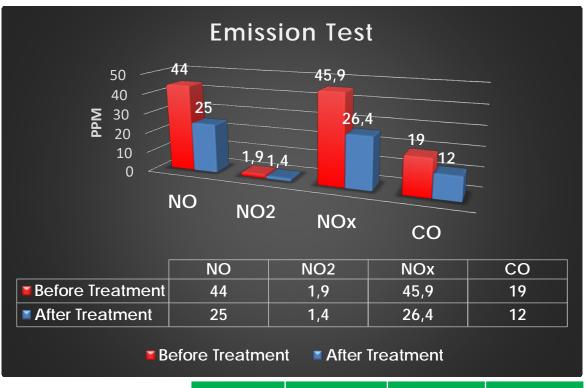
<u>NO</u>	NO2	<u>NOx</u>	<u>co</u>
Everage reduction %	43,2 %	26,3 %	42,5 %	36,9 %
Fuel reduction %	Measurement performed after driving 2000km A saving of 9.6%

The first and second measurement was carried out with the engine running at 1200 rpm. Between the first and second measurement the bus has driven for 348,3 km.

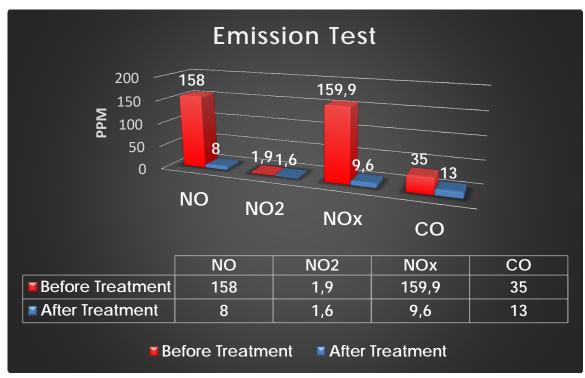
#### Test Bus 2 before and after measurement "NPS Engine Improvement treatment"

<u>NO</u>	<u>NO2</u>	<u>NOx</u>	<u>CO</u>
Everage reduction %	95 %	15,8 %	94 %	62,9 %
Fuel reduction %	Measurement performed after driving 2000km <u>A saving of 9,4%</u>

The first and second measurement was carried out with the engine running at 1200 rpm. Between the first and second measurement the bus has driven for 298 km.

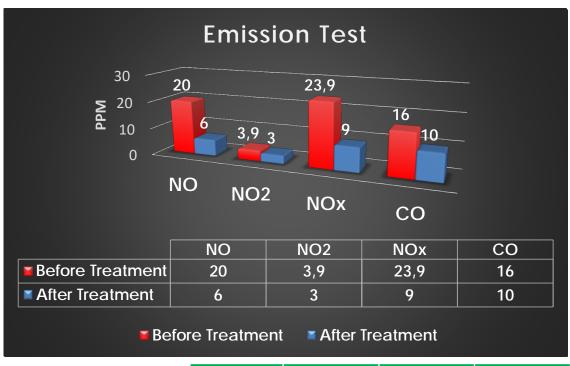
## Test Bus 3 before and after measurement "NPS Engine Improvement treatment"

<u>NO</u>	<u>NO2</u>	<u>NOx</u>	<u>CO</u>
Everage reduction %	70 %	23,1 %	62,3 %	37,5 %
Fuel reduction %	Measurement performed after driving 2000km <u>A saving of 9,6%</u>

The first and second measurement was carried out with the engine running at 1200 rpm. Between the first and second measurement the bus has driven for 343 km.

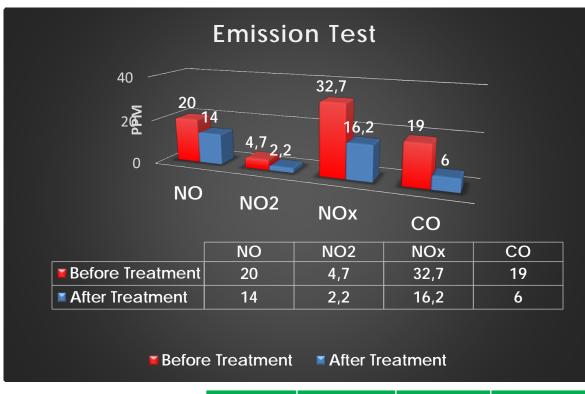
### Test Bus 4 before and after measurement "NPS Engine Improvement treatment"

<u>NO</u>	NO2	<u>NOx</u>	<u>CO</u>
Everage reduction %	30 %	53,2 %	50,5 %	68,4 %
Fuel reduction %	Measurement performed after driving 2000km <u>A saving of 9,4%</u>

The first and second measurement was carried out with the engine running at 1200 rpm. Between the first and second measurement the bus has driven for 328 km.
